FIRE ISOLATOR

FIRE RESEARCH ON
EV-CAR FIRES

SAFETY ONBOARD FERRIES
AND IN CARPARKS

FIRE SAFETY TESTING IN FREDRIKSHAVN

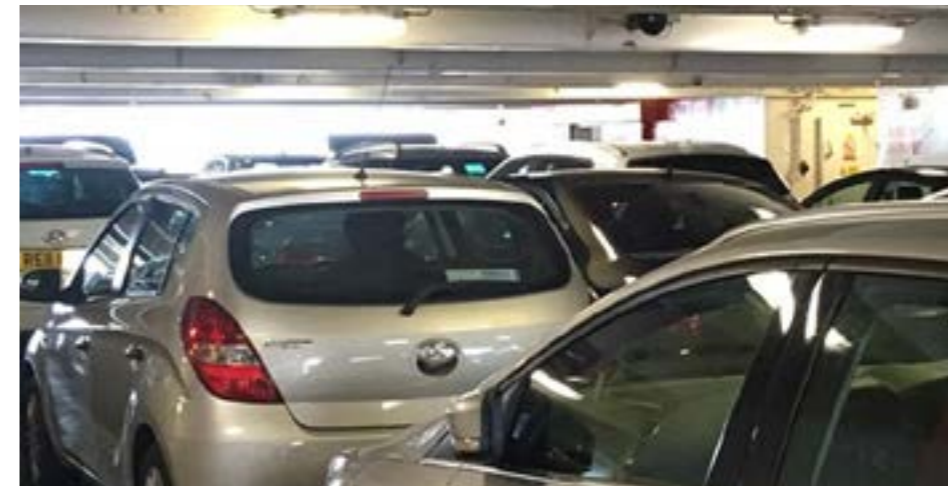
(cc Tripadvisor cars parked closed to each other on a ferry)

If an EV vehicle is parked on the cardeck during peak season, it will be among several cars that are close together and difficult to access. Once a fire starts at such a vehicle, it is extremely difficult to extinguish or otherwise approach.

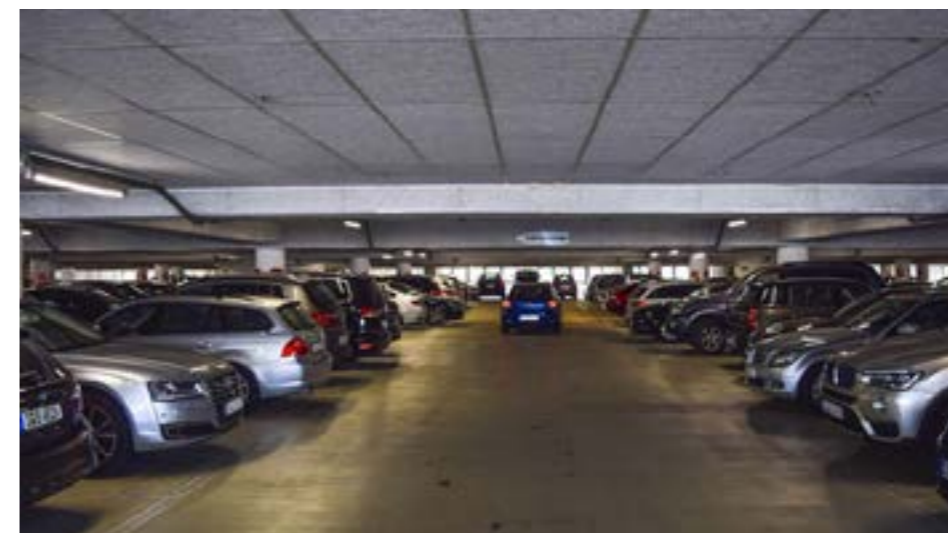
(cc Newgate-UK.com, cars parked close to each other in a underground carpark)

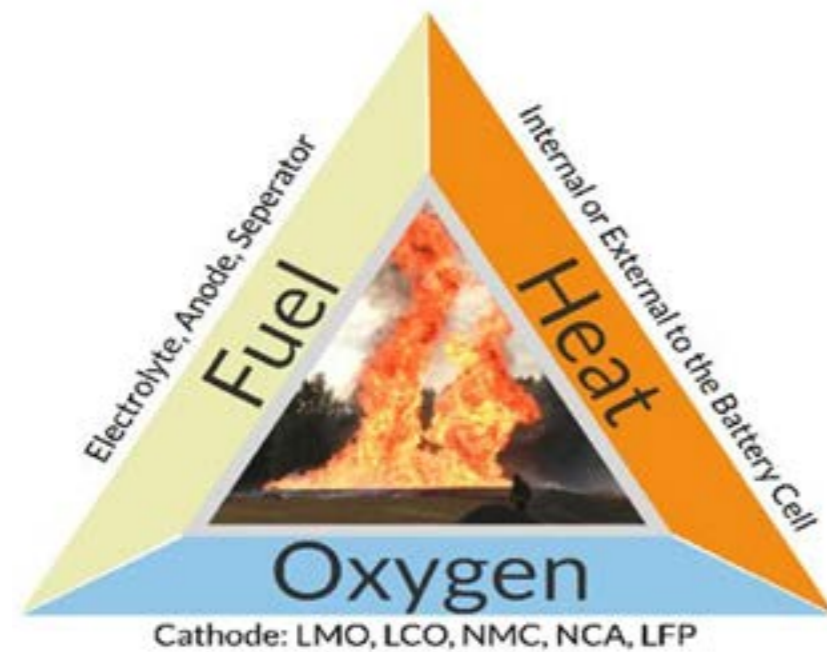
Figure 2 - The fire triangle for Lithium-ion batteries

The main battery hazards are usually the result of external or internal short circuits, high or low temperatures, overcharging or over-discharging. These mechanisms can lead to exothermic reactions within the battery. When the temperature becomes high enough, or when an ignition source is present that ignites the flammable gases released from the battery, the fire triangle seen in Figure 2. is completed.

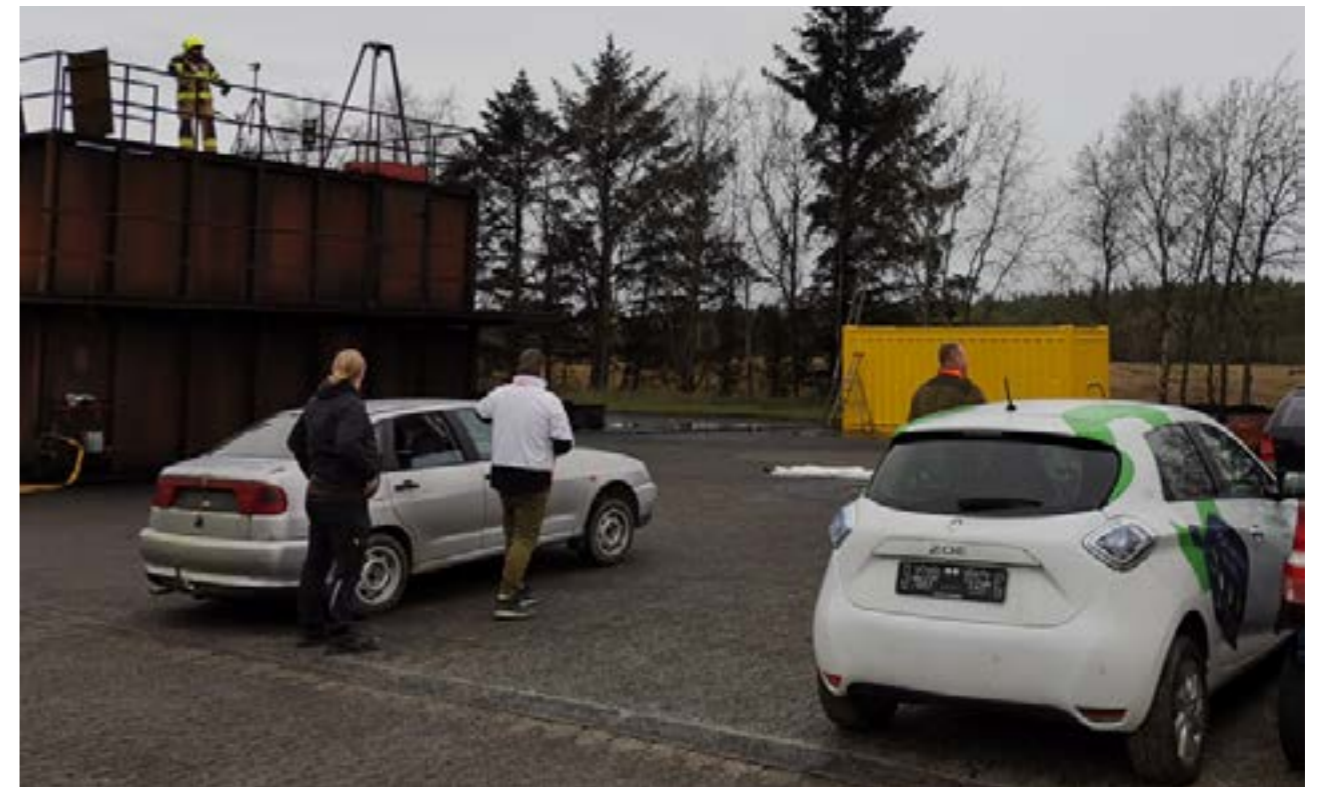
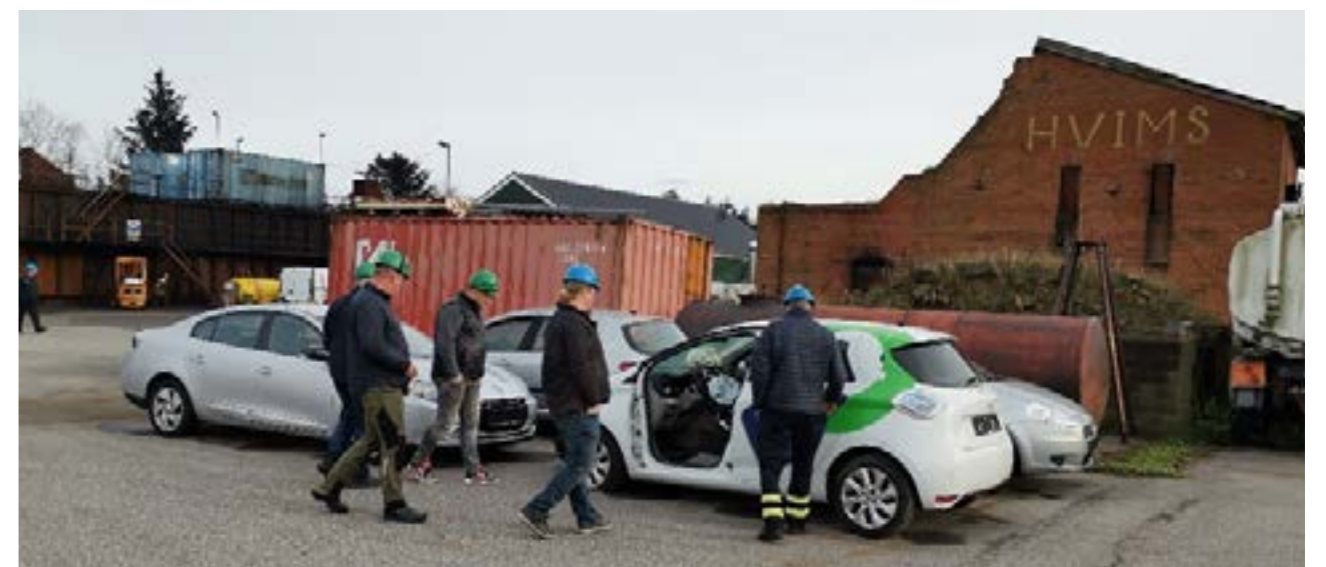
For testing purposes the location of Nordjyllands Beredskap site was chosen. Following cars have been used for testing.

Renault Zoe (EV), Seat Cordoba, Renault Fluence

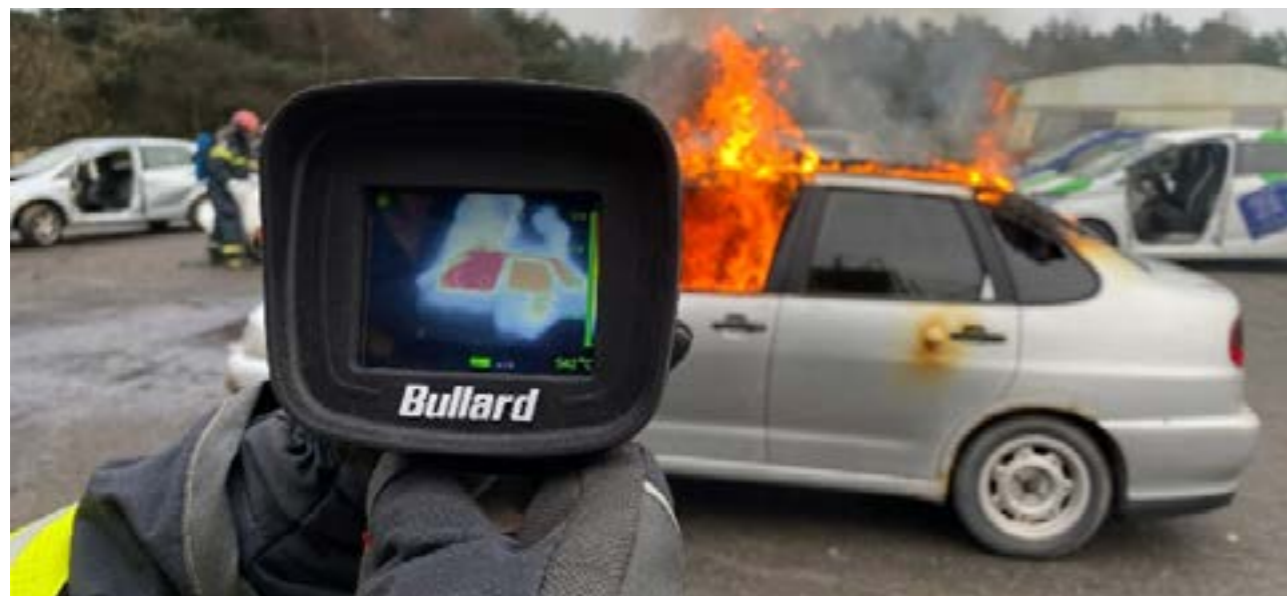
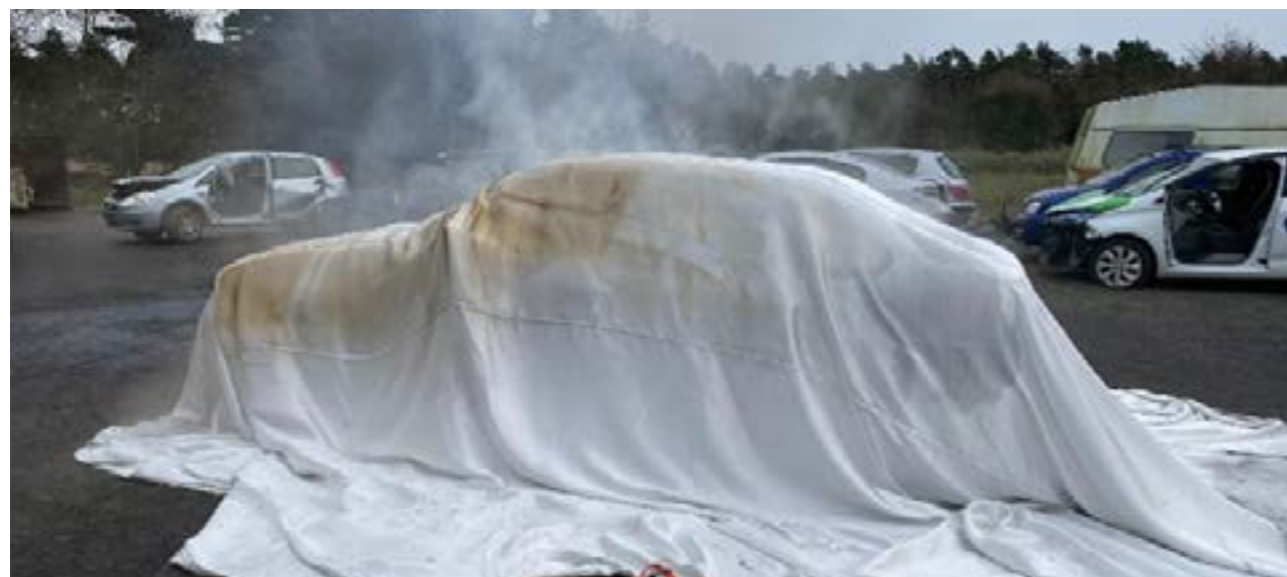
A long-term test was done on a normal combustion vehicle, our Seat.

Here the temperature was around 500-600 °C.

Blanket could stand temperature without any defects except discoloring due to smoke

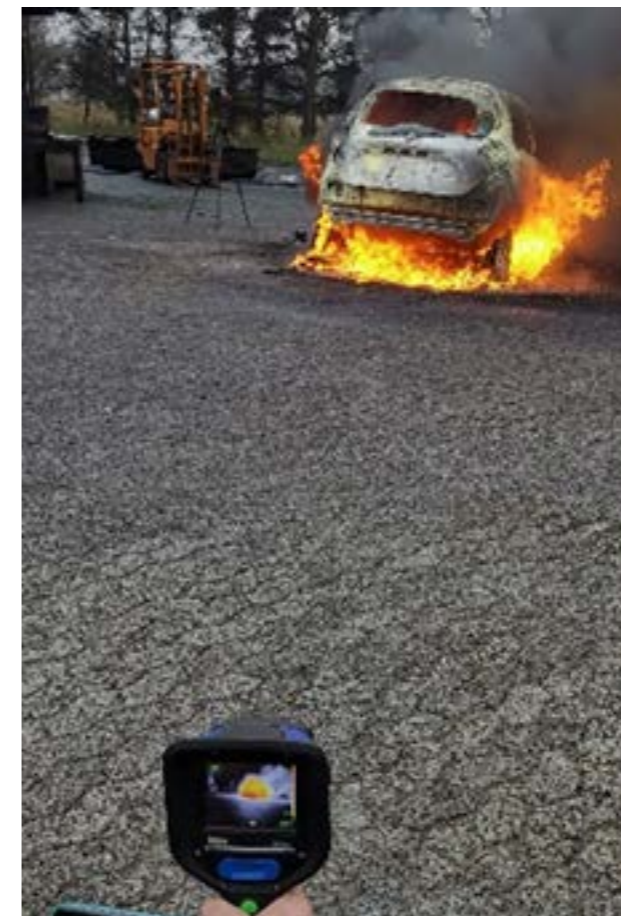
The same blanket was then used again on an EV with a burning battery, where the temperature rose to 1325°C for just a short period of time when the thermal runaway of the batteries occurred again, the blanket easily withstood the temperature and kept the fire contained.

The blanket was reused from a normal car to an EV car. Best practice is to use a light colored blanket to detect damage, cracks or tears in the blanket.

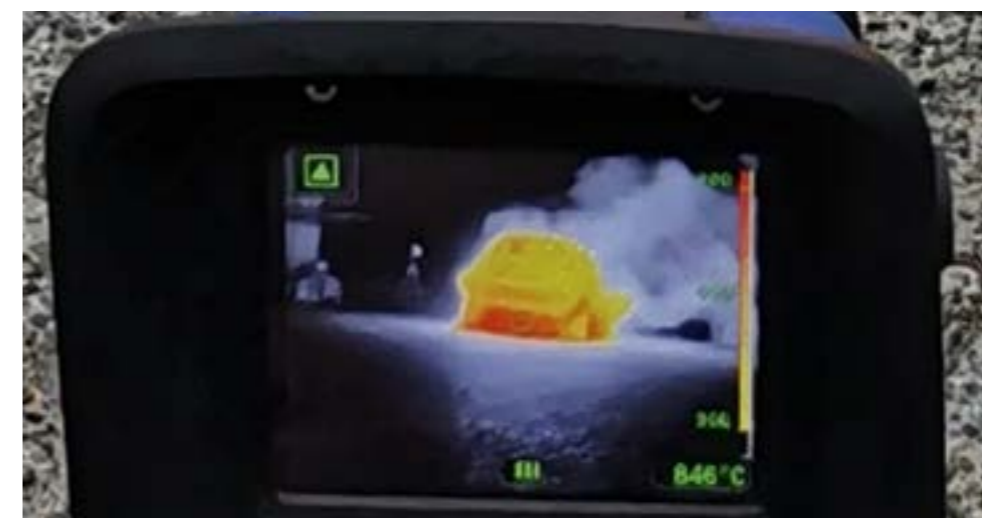
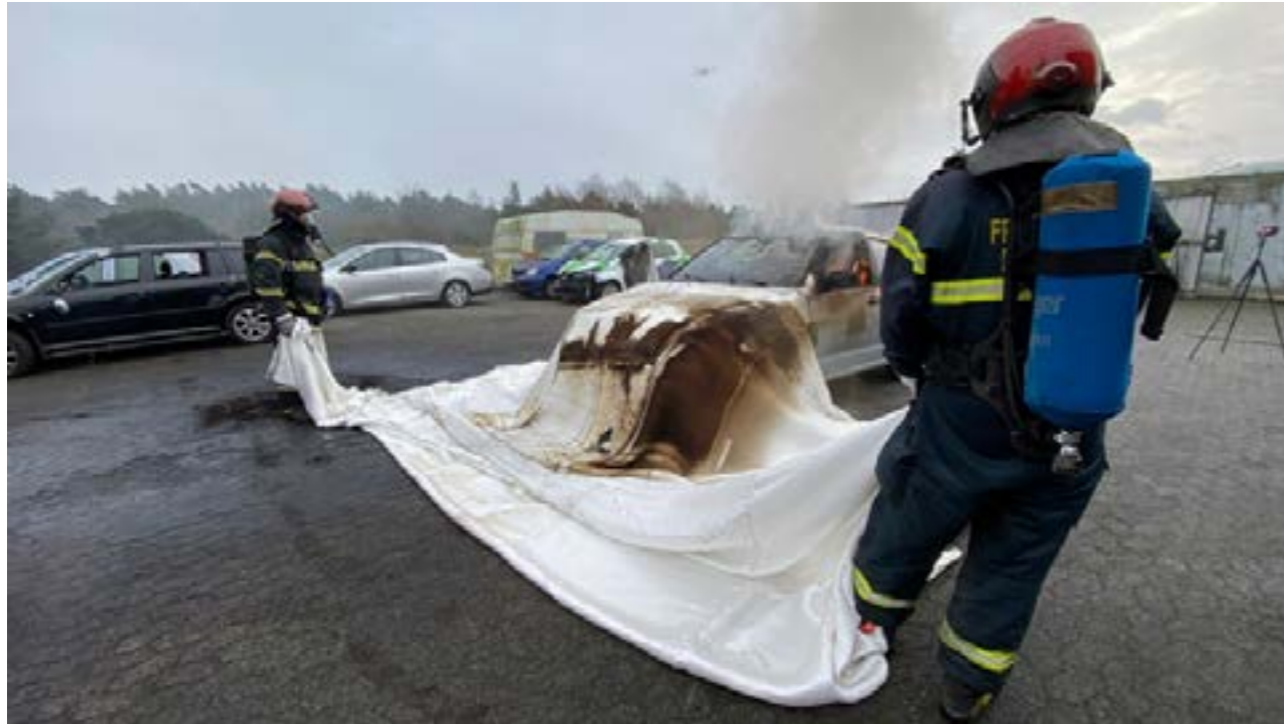
The fire blanket can withstand very high temperatures but does not stand up well to sharp objects or overly rough handling of the blanket. The installation of the blanket must therefore be done carefully, without hard, jerky movements, so as not to damage the fabric or the loops.

After use, the blanket will discolor but can be reused if only used for limited period of time.

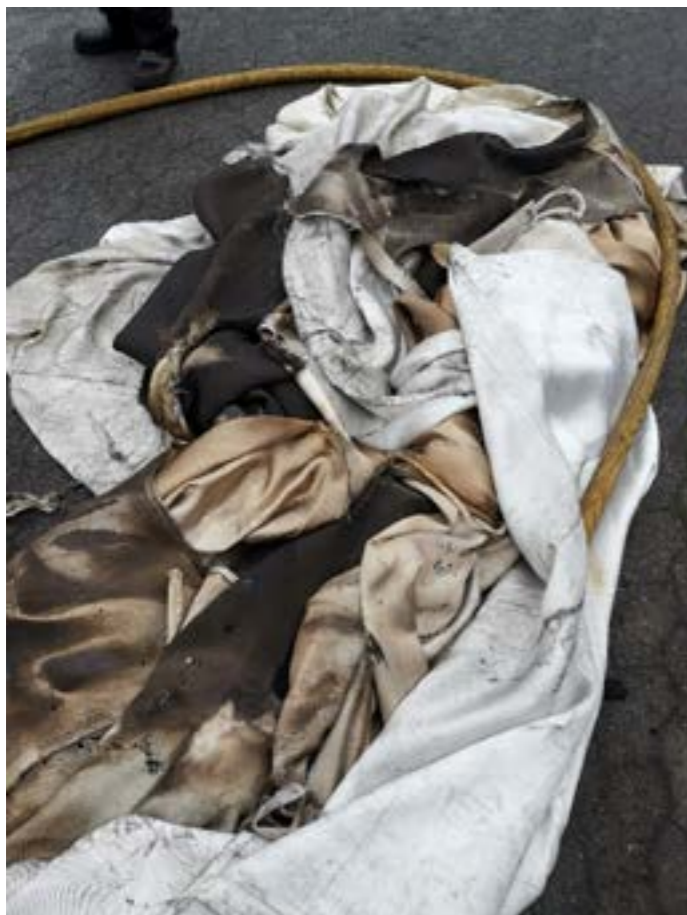
However, after hours of use in a fire involving Lithium batteries, the blanket is badly discolored and so dirty and smells so terrible that it will be generally disposed of according to the firefighters' statement.

Also due to the fact that the blanket is poisoned with HF gases and other toxic fumes.

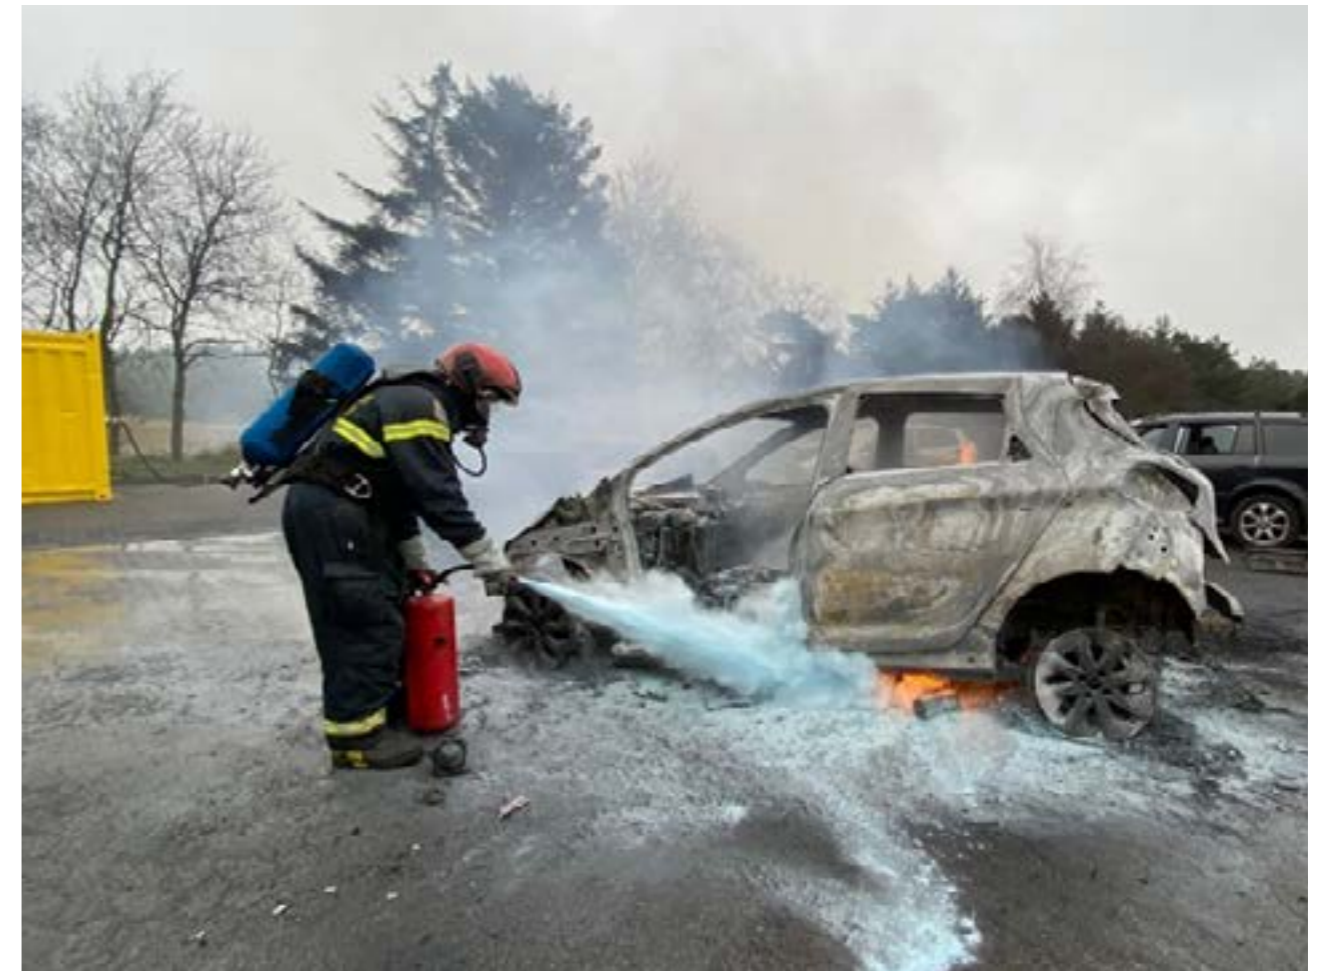
These photos show the blankets after hours of use on a burning vehicle.

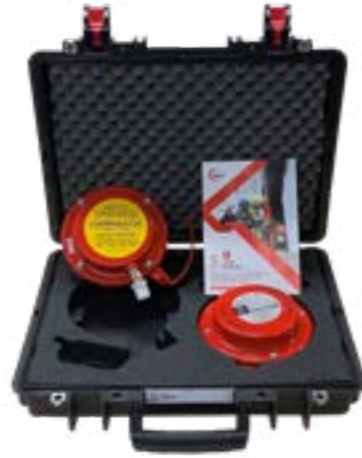
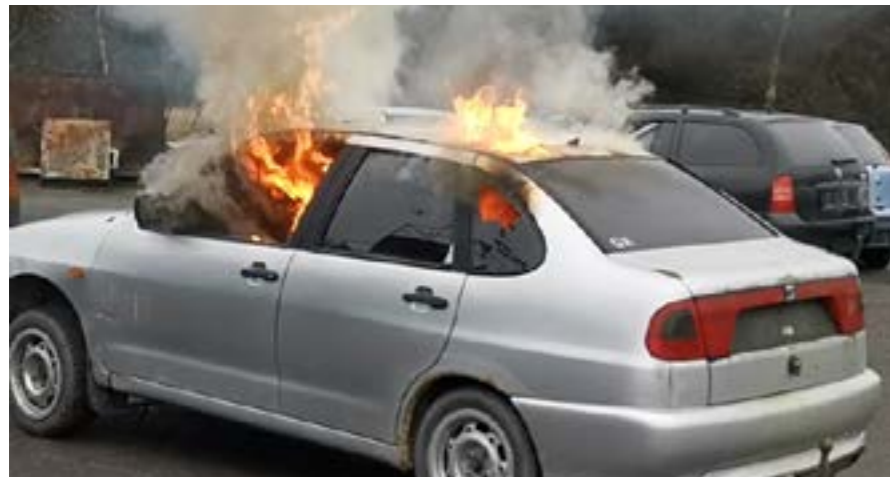
Fire before

We tested the aerosol units, see photo 1, in a burning car (our Seat) and once the gas spread in the car, the fire was extinguished in seconds, which however caused a huge amount of smoke.

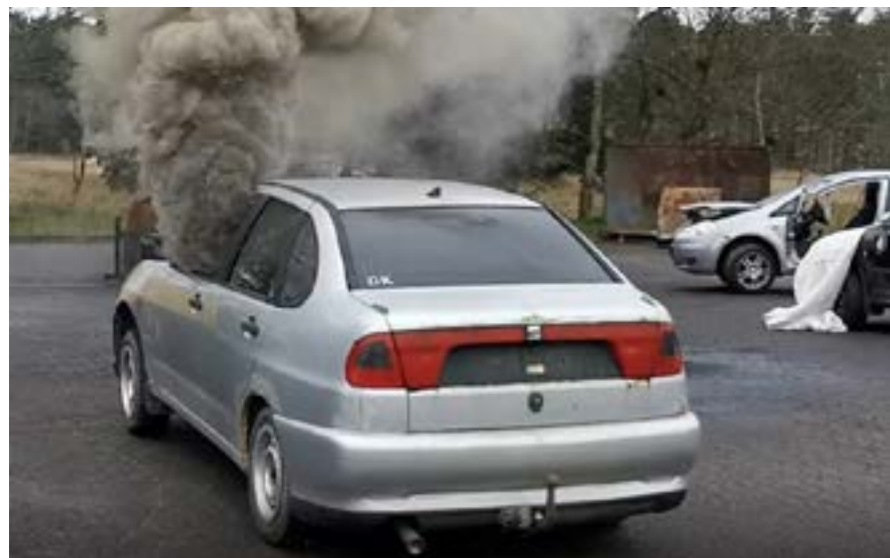
The fire 10 seconds after inserting the potassium salt aerosol units inside the burning car

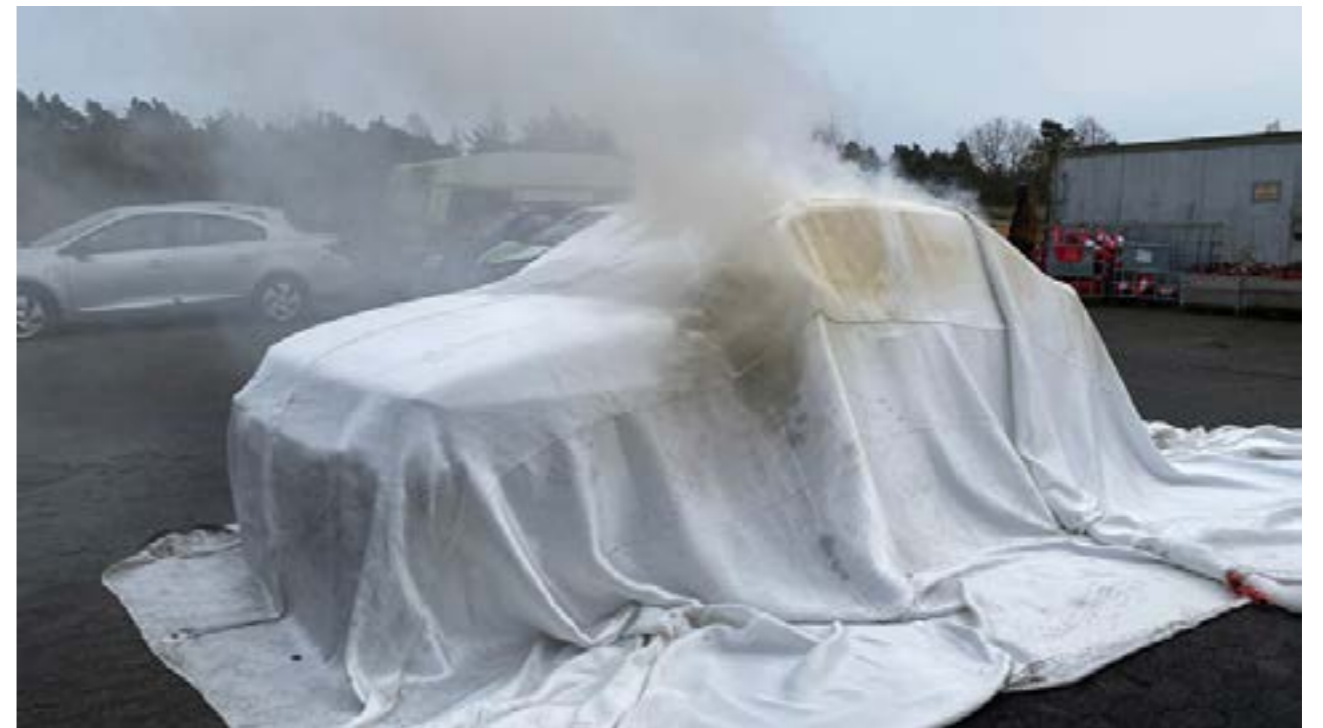
When covering a vehicle with the VR0906Li blanket, the fire was isolated, and when a aerosol unit was inserted into and under the vehicle, the fire was under control for several hours.

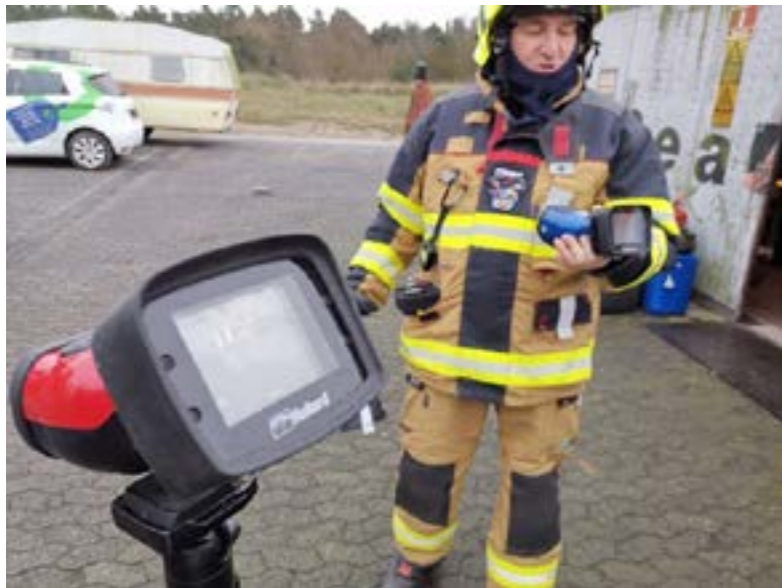
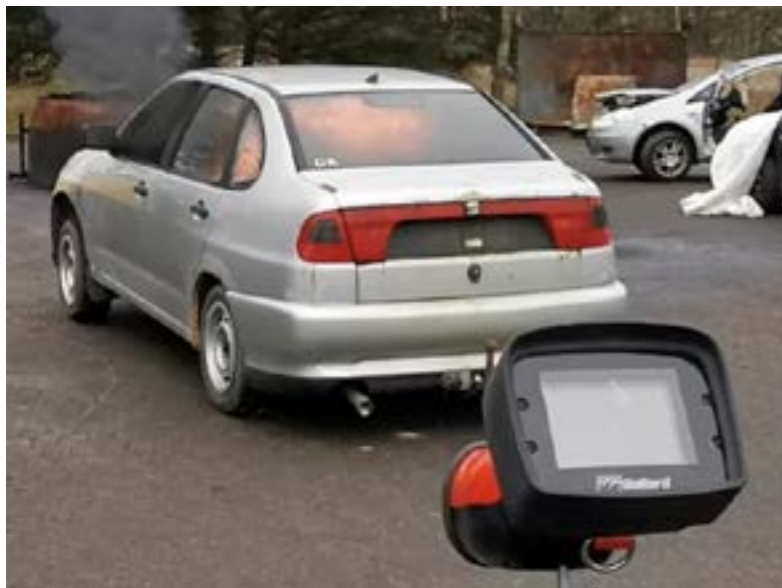
Specialist Rodic from Bullard visualized and compared the temperature range of a fire in a combustion car (gasoline, diesel) and an EV car.

- 1 Temperature range Combustion cars up to 600-700 °C.
- 2 Temperature range EV cars (our specimen) 700-800 °C with short bursts up to 1325 °C.

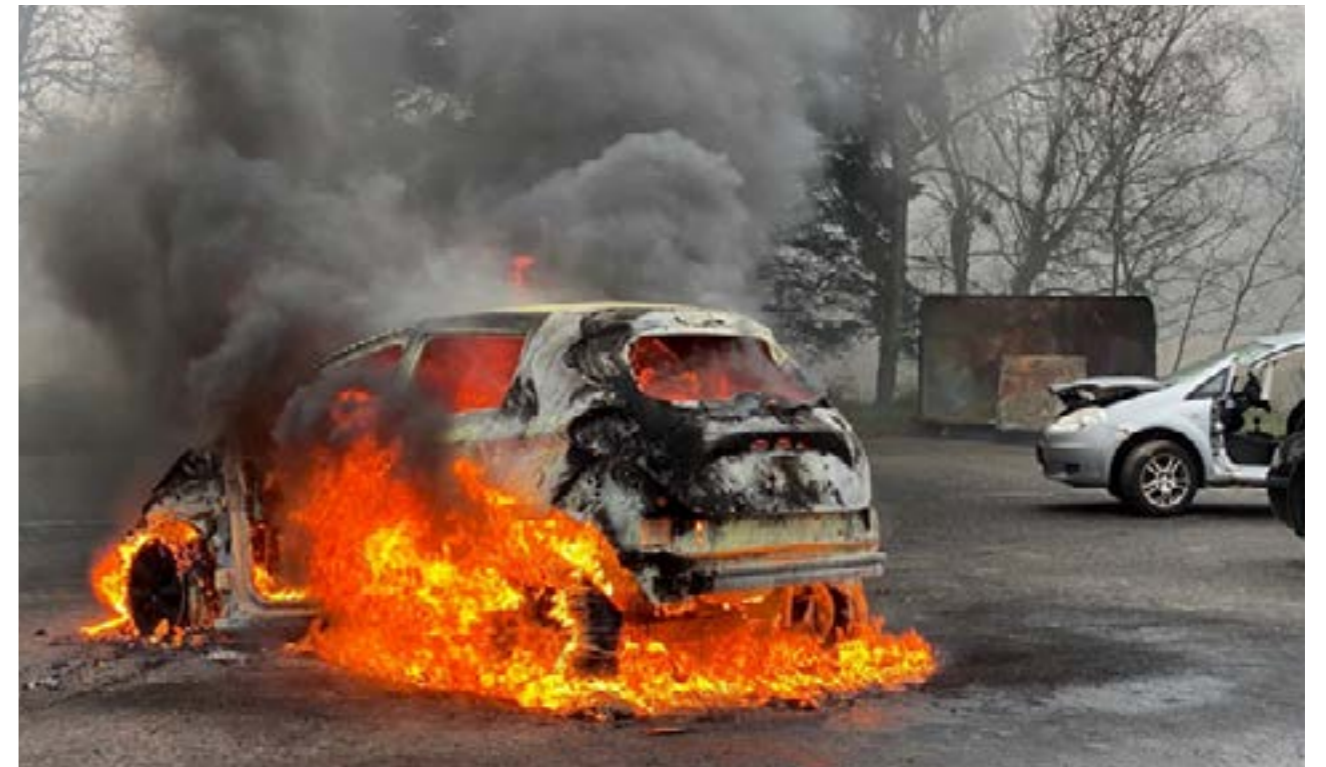
The photo below is from 20 seconds after we tried to extinguish the car with water, this went on and on and on.

After 10 attempts of trying to extinguish the fire, we stopped due to the fact that after every 5 seconds after the fire hose stopped, the fire automatically reignited.

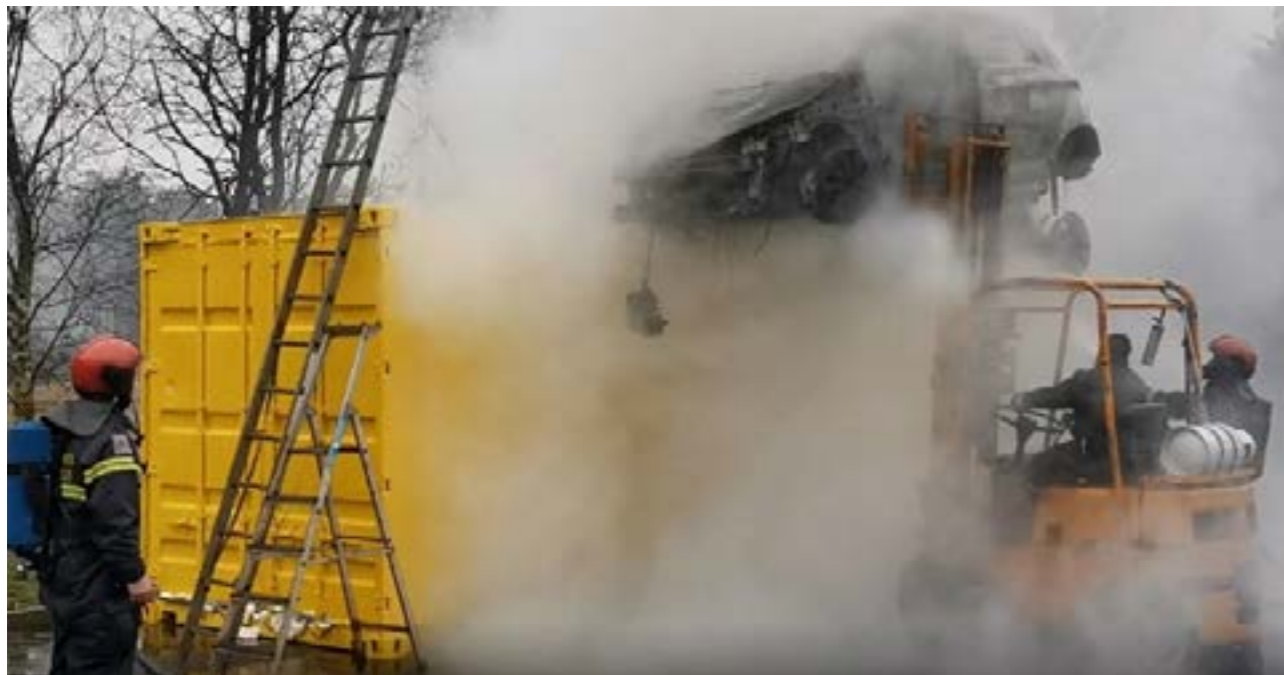
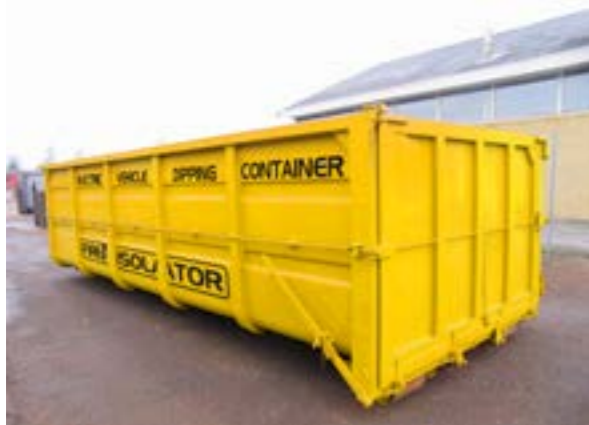
Our EV, covered by the fire blanket, was still burning mildly after several extinguishing attempts. As has been practiced in several countries, EV cars can also be dumped into water-filled containers.

This test also used a modified container with special inlet and outlet for water.

The ditched car is harmless, nothing more happened except that the temperature of the water raised from 8 °C to 15 °C within an hour.

It is recommended that the car be left in there for 2 weeks. After this, the water is chemical waste and must be treated as such and disposed of in a manner prescribed by local authorities for the discharge of contaminated water.
